Jamie Lavigne, MESc student, Dept. of Geography Supervisors: Dr. April James & Dr. Dan Walters

Callander Bay

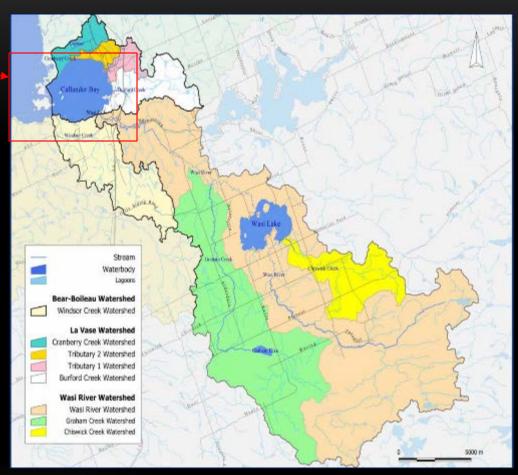
Land classes of Callander Bay. Courtesy of Hutchinson Environmental Sciences Ltd. (2011).

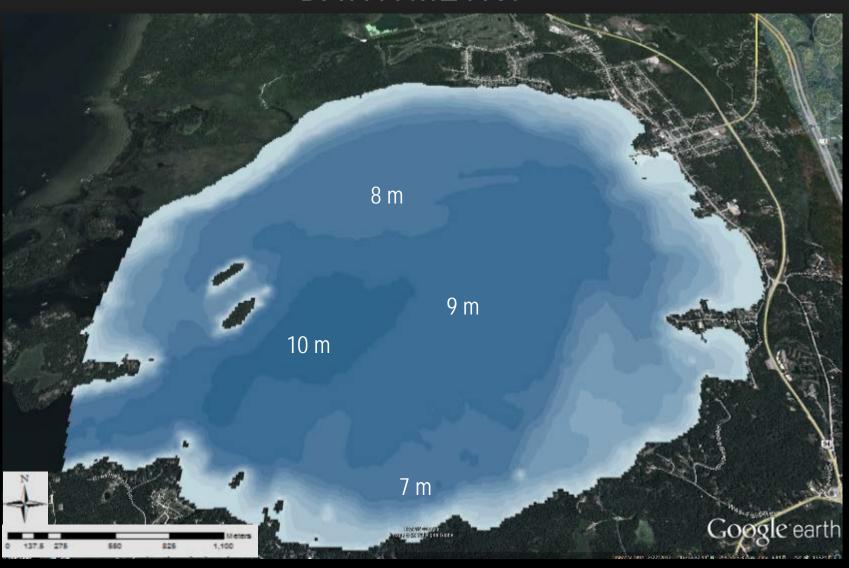
Callander Bay bathymetry. Map digitized courtesy of Dr. Krys Chutko. Landscape courtesy of Google earth, 2013.

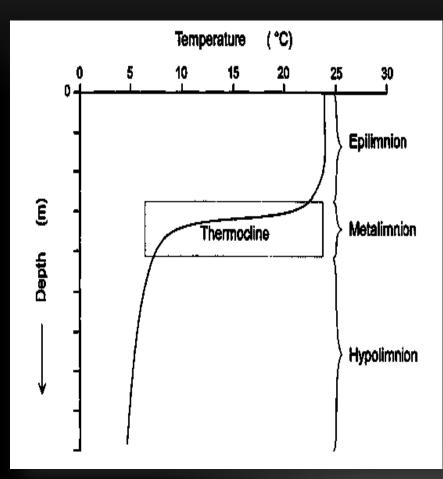
Typical temperature profile from a temperate stratified lake showing three layers based on differences in density. Courtesy of Thomas *et al.* (1996).

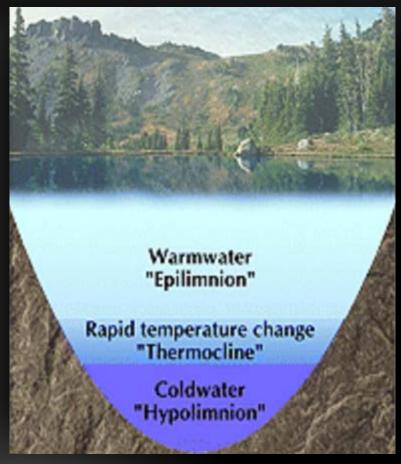
Lake image of summer stratification showing different layers in density. Courtesy of University of Guelph, (2013).

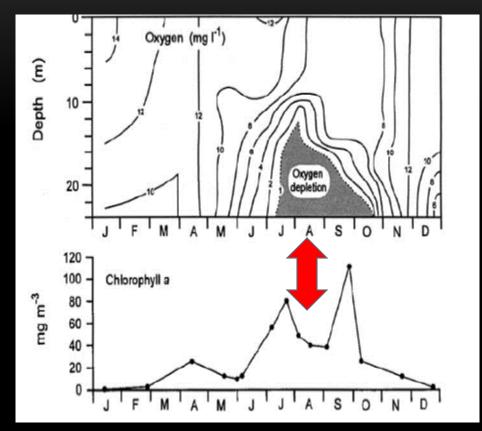
Oxygen concentration and chlorophyll a. Notice as oxygen depletion occurs chlorophyll a concentration increase in the summer months. Courtesy of Thomas *et al.* (1996).

- Sediments act as a sink for nutrients with the exception of periods of anoxia (lack of oxygen).
- During anoxia, nutrients are released into the hypolimnion (bottom waters) (Pettersson, 1998).
- Anoxia = < 1 mg/L of dissolved oxygen

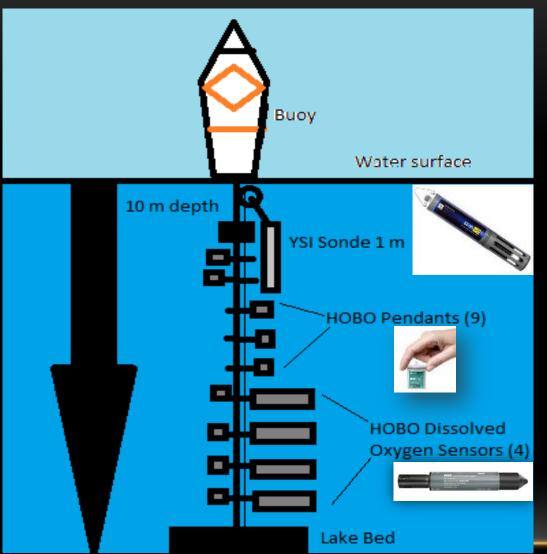
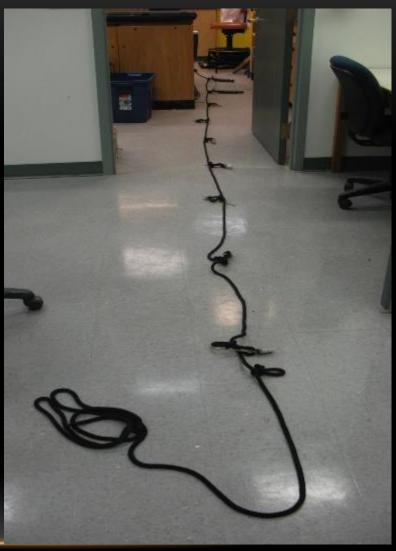
EQUIPMENT ON BUOY

Rope with equipment that was suspended from buoy, 2013.

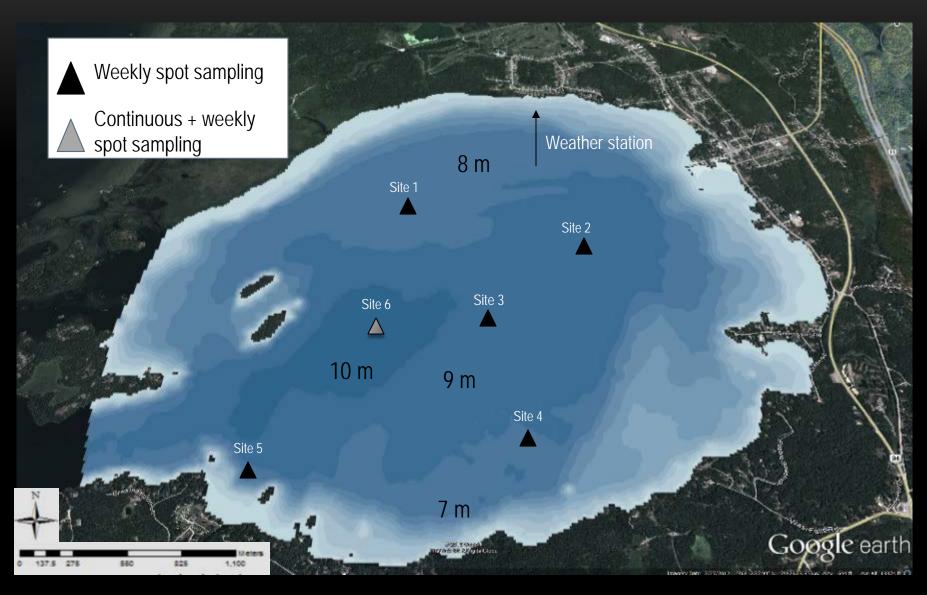
BUOY (SITE 6) AND SPOT SAMPLING SITES

Callander Bay bathymetry. Map digitized courtesy of Dr. Krys Chutko and landscape courtesy of Google earth, 2013.
